DEPARTMENT OF NATURAL RESOURCES
DIVISION OF OIL, GAS AND MINING

RE: Site Inspection, Native Asphalt Company, Cameron #1 Project,
S/047/036, Uintah County, Utah

Date of Inspection: October 3, 1991

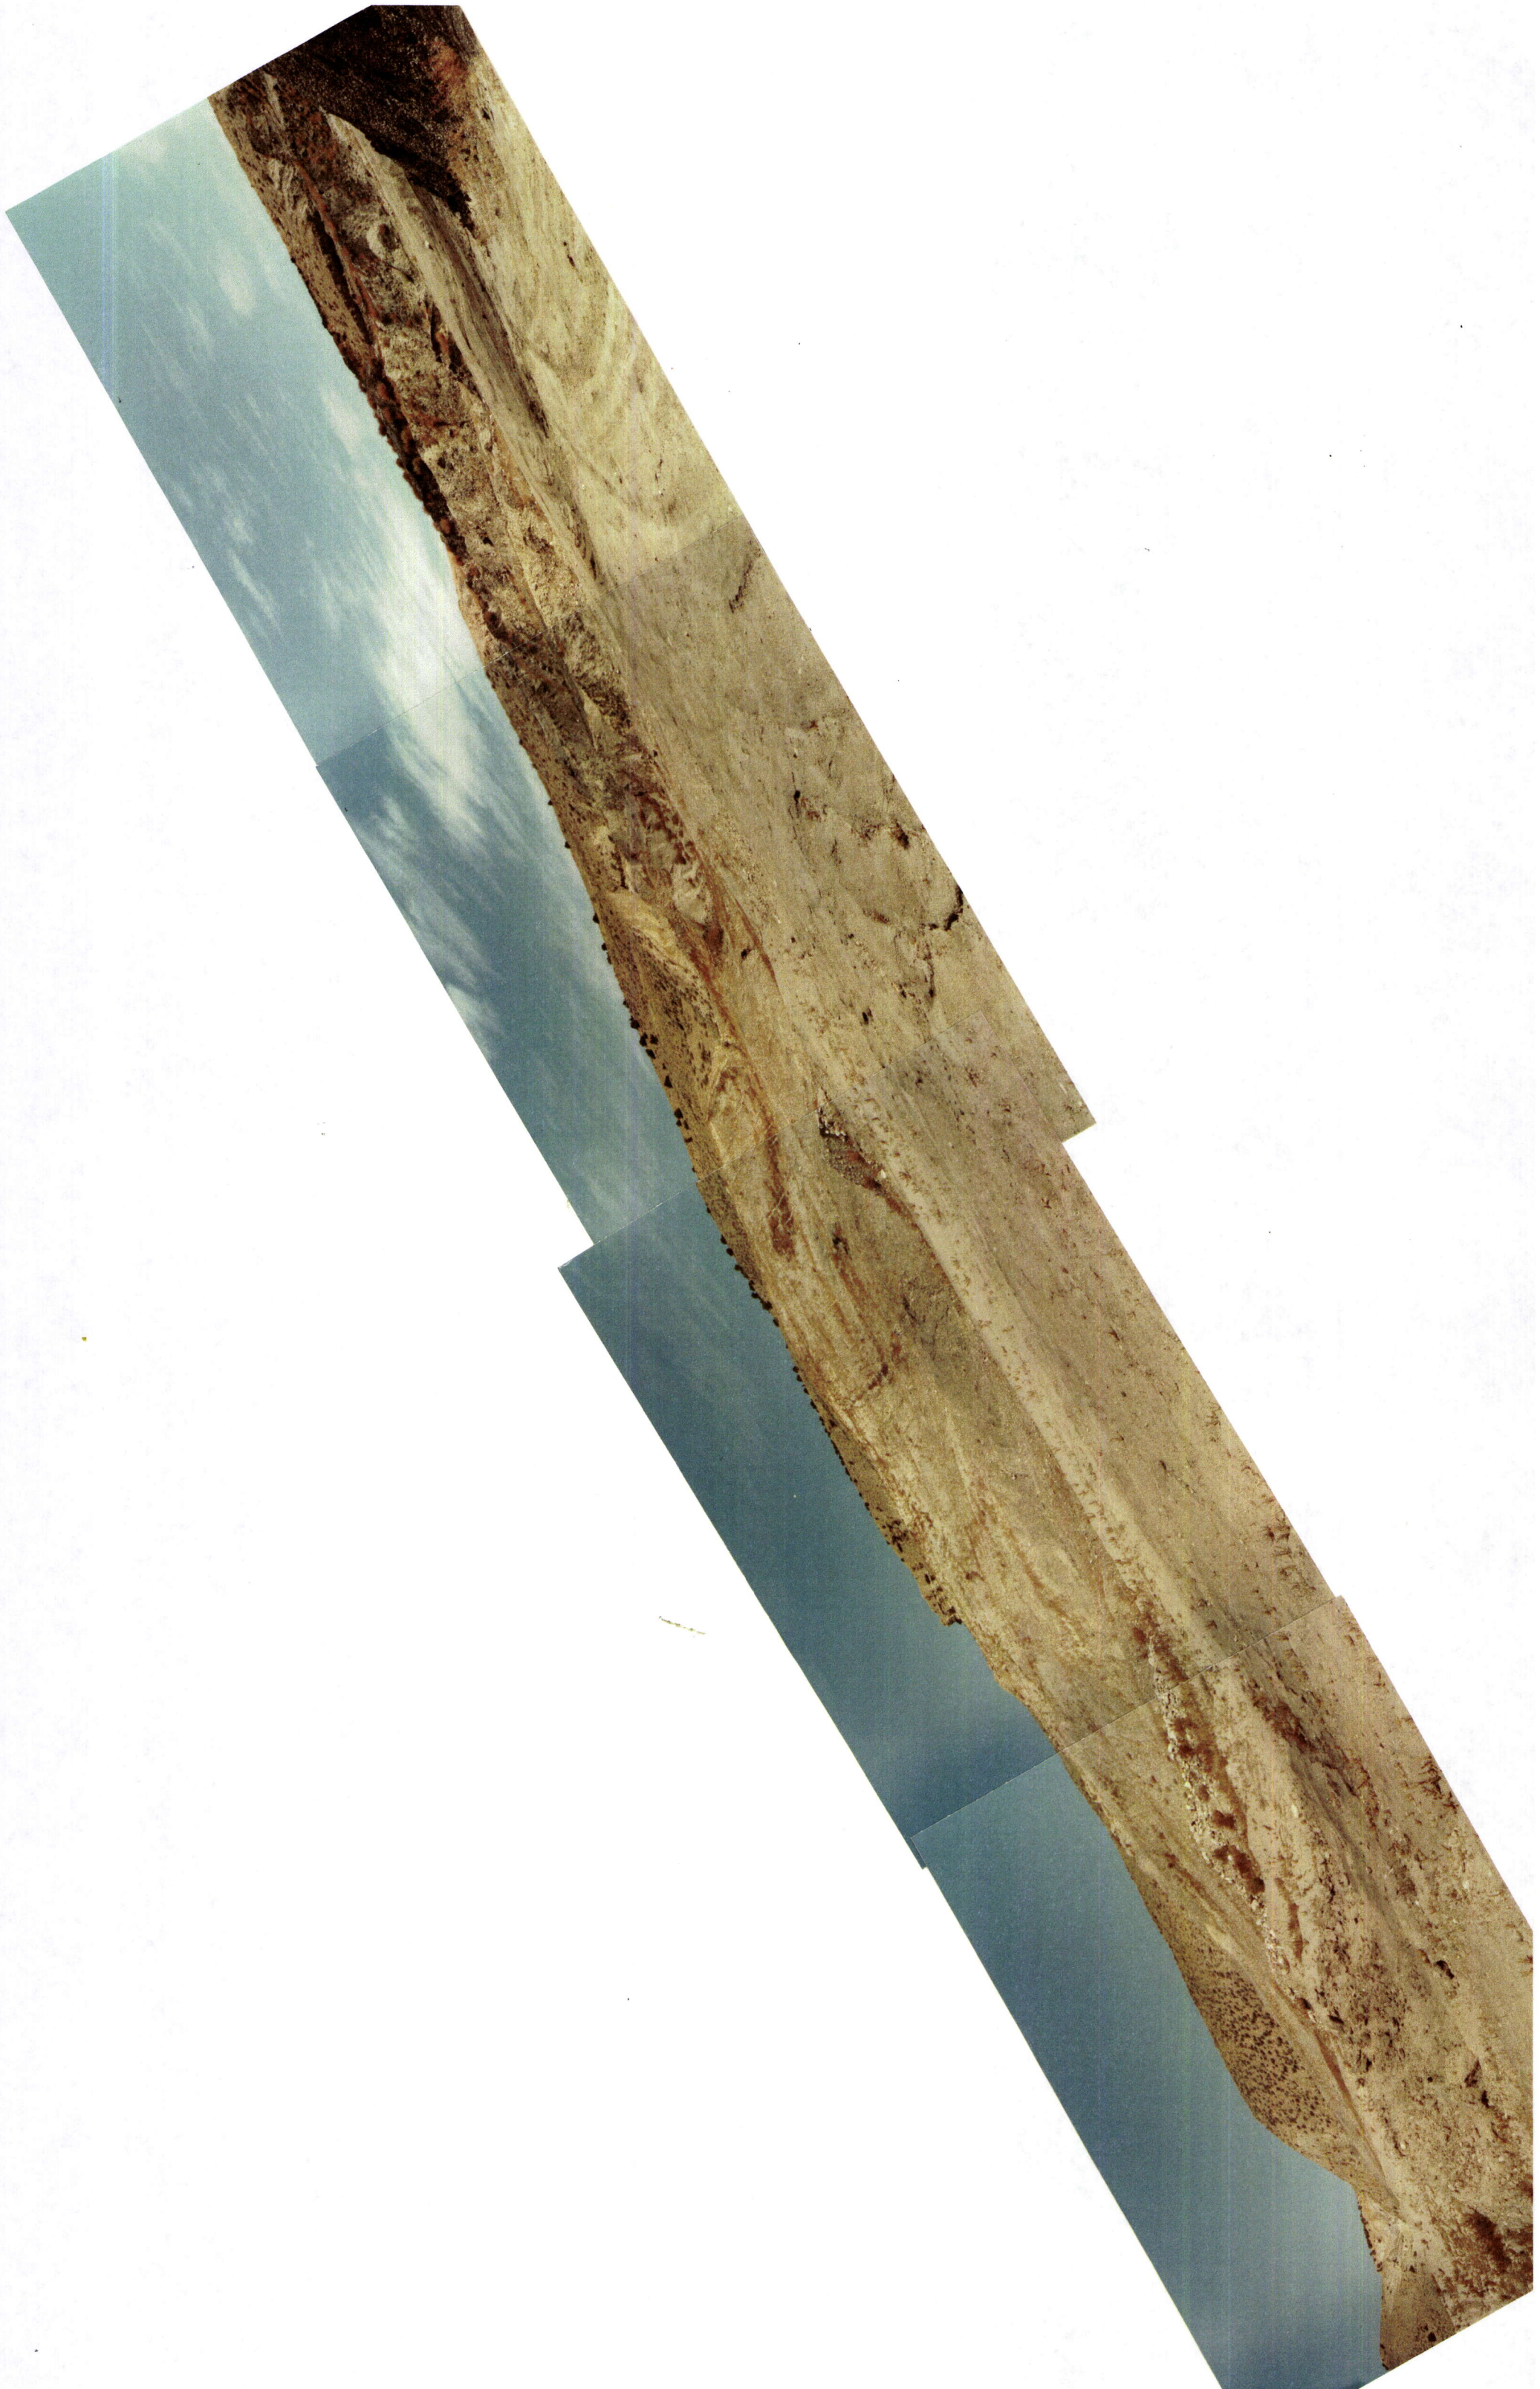
May 1991. Examination of the area showed most of the plants to be invader species such as russian thistle and halogeton. Photos were taken to document the status of this area.

5/6477/0266
NATIVE AGRIKULT CO
CAMERON #1
10/3/91
PROGRAMA FROM W--E
SCARPED AREA WHICH
STOWING TILES
WAS SEEDS. WHICH NEED
-NOTE REMAINING TILES
ROAD (FIRE FIGHT) WHICH
TO BE REPAIRED

Some additional reclamation of the area is still needed. Several small piles of material need to be regraded. The road and berm sloping up the side of the scalped area need to be regraded. Mr. Lindsey indicated that they would like to clean up the breached dike area near the wetlands. At the time of this inspection the breached area had recently sloughed in around the drainage of the wetlands. It was suggested that the bank of the breached area could be pulled back and made into a gentler slope without affecting the wetlands. Some piles of gravel located over the rise to the east of the stockpiles will also need to be regraded or removed.

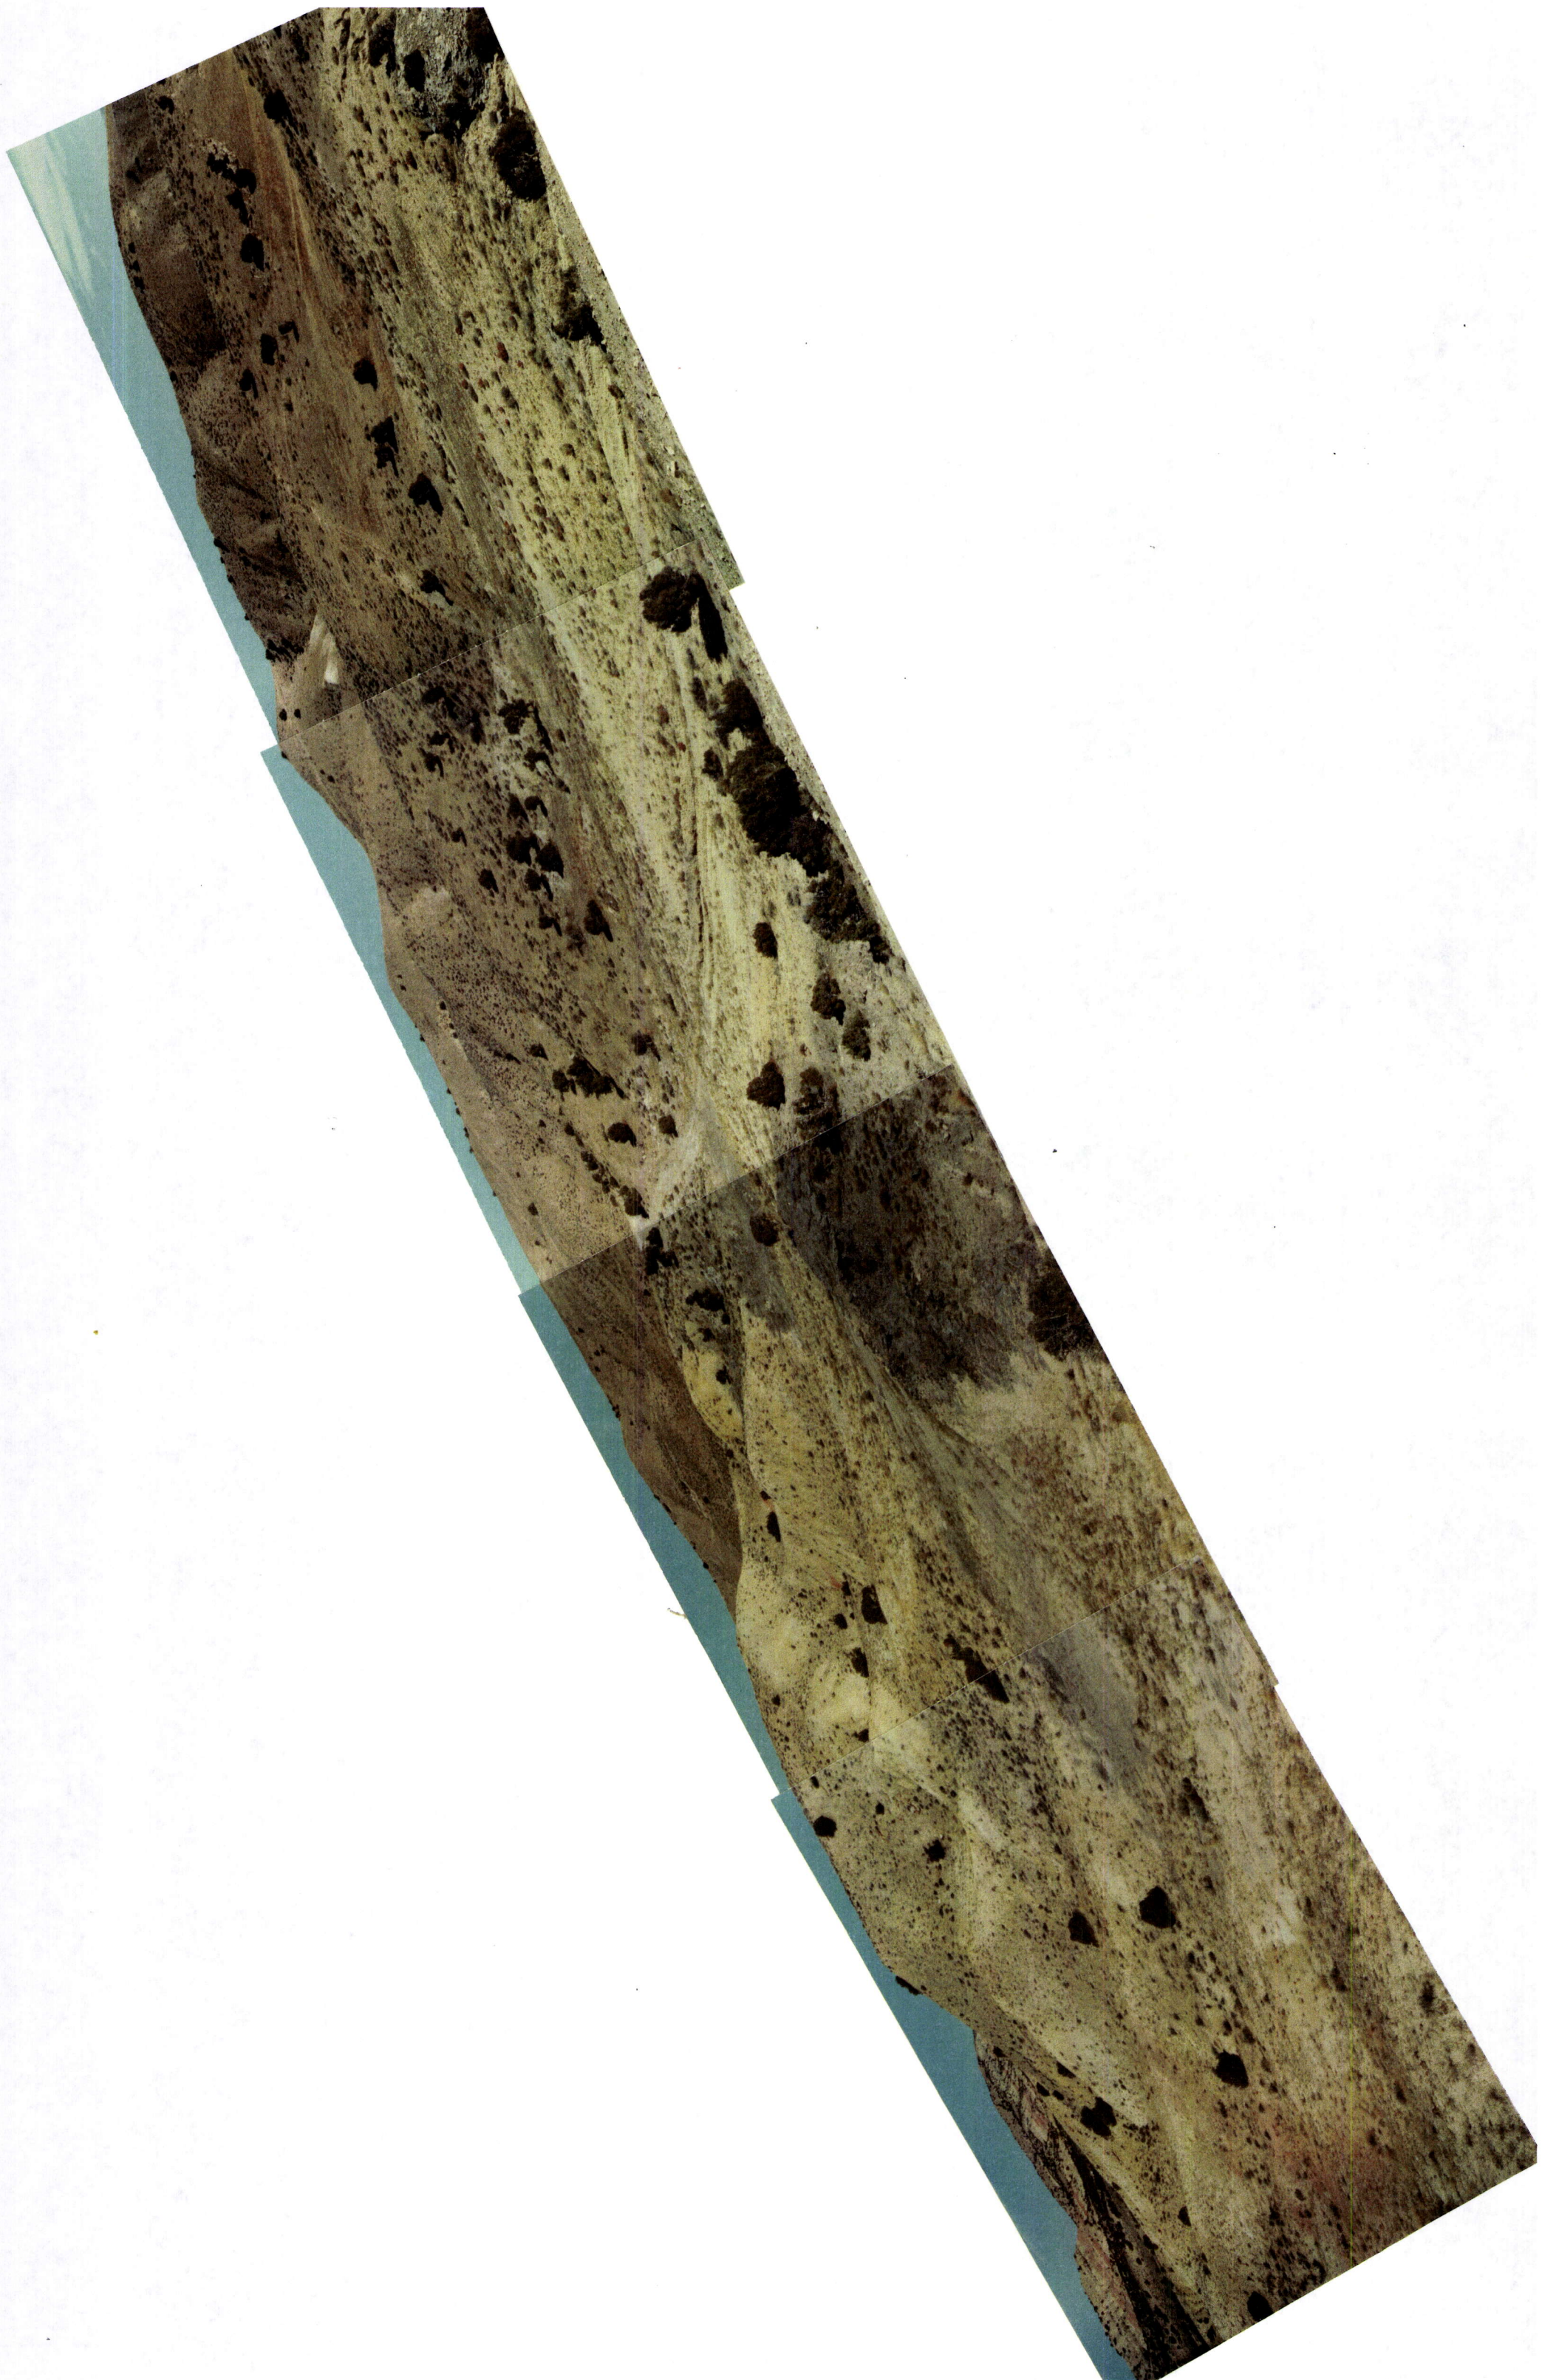
The pros and cons of three general locations for the proposed pit location were discussed and one location was selected as the most favorable. This area consists of fairly level terrain, little topsoil and vegetation, and is situated out of the major drainage channels. An outcrop of asphalt, with a lone tree growing out of it, sits south-southeast of the proposed pit location. This location has very little if any, overburden or topsoil overlying the asphalt deposit.

Asphalt Co.
Native New Pit
10/17/036 PROPOSED LOCATION IS N/100E TREE
SITE OF PROPOSED PIT LOCATED w/100E TREE
- PROPOSED PIT LOCATED
OF ASPHALT
10/13/01

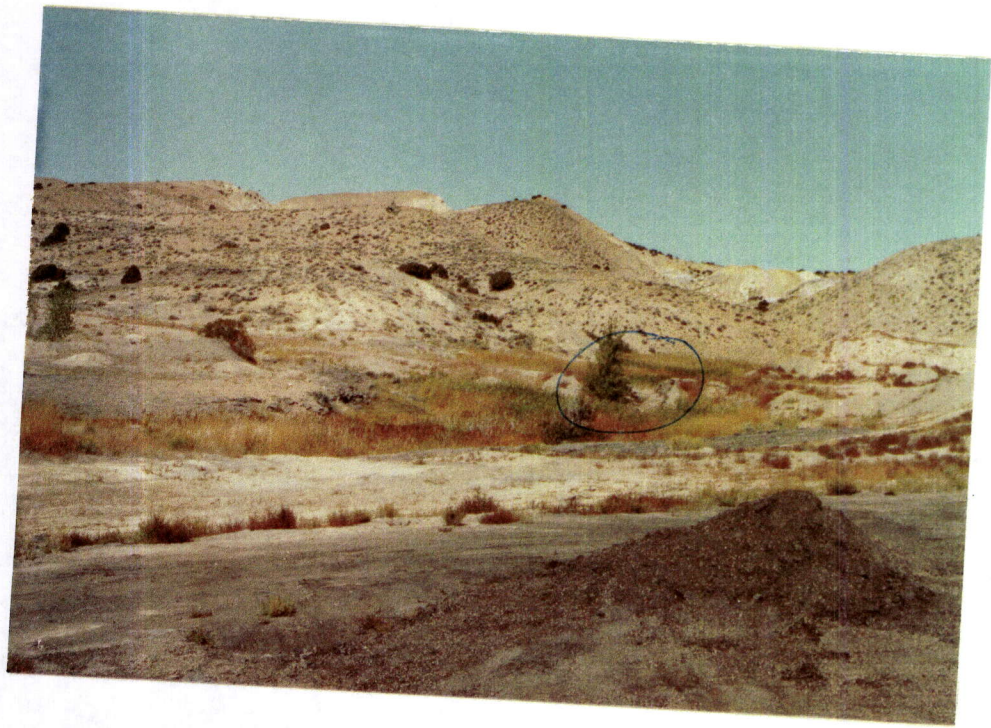
S/047/036 CAMERON #1
NATIVE ASPHALT Co.
10/3/91
WETLANDS AREA
NOTE BREACHED DIKE/ROAD AREA

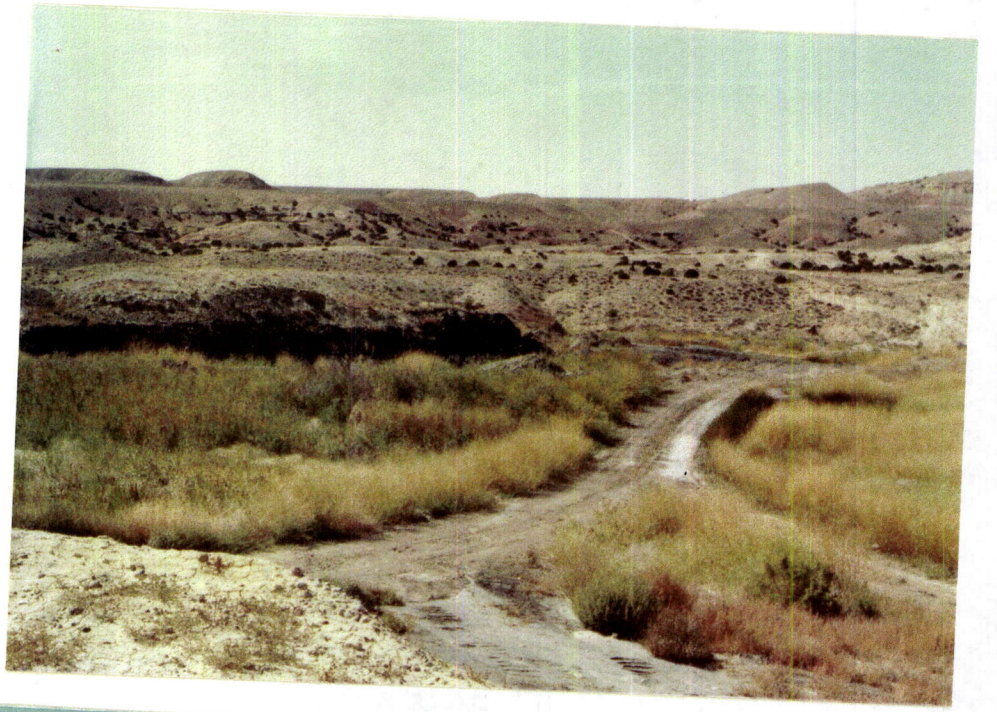
We examined the remainder of this site and found no causes of concern. Photos were taken of the pit area and the adjacent wetlands area. The plants were considerably tall given that this was a wet year.

S/047/036 CAMERON #1
NATIVE ASPHALT Co.
PIT AREA & WETLANDS VEGETATION
10/3/91

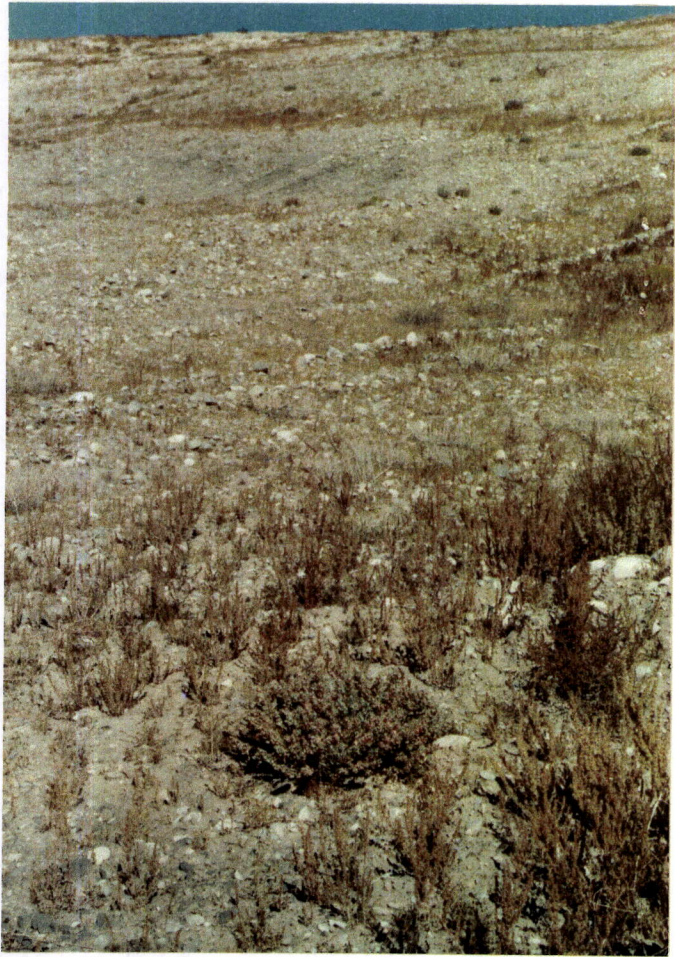
S/047/036 CAMERON #1
NATIVE ASPHALT Co.
10/3/91

DETAIL OF AREA SEEDED
IN MAY 1991

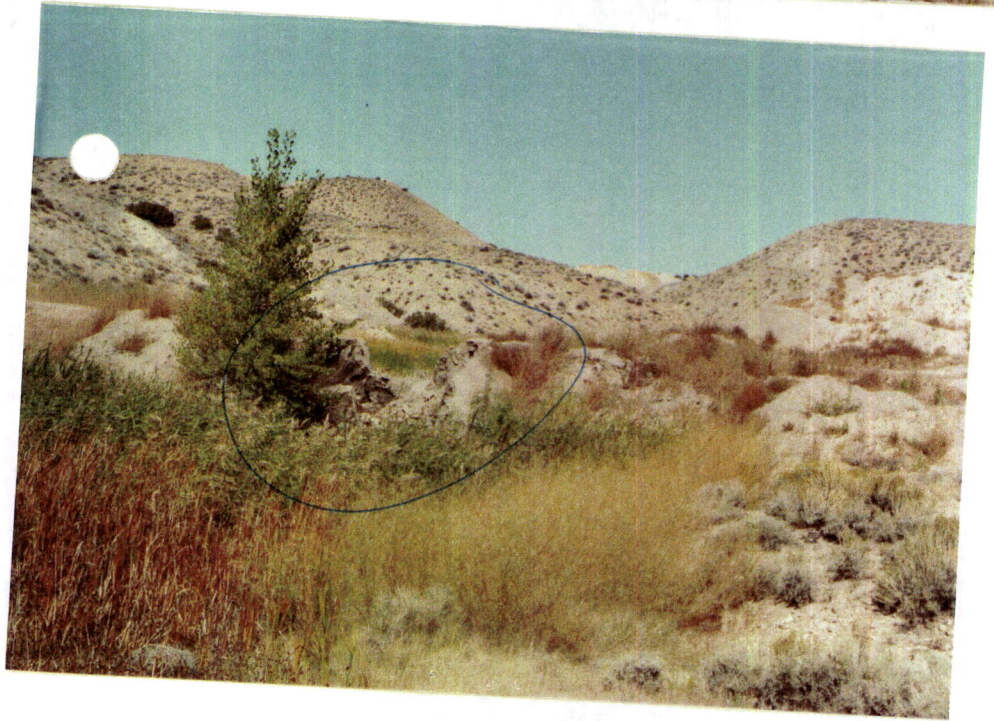
S/047/036 CAMERON #1
NATIVE ASPHALT Co.
10/3/91

BREACHED DIKE/ROAD AREA
NEAR WETLANDS

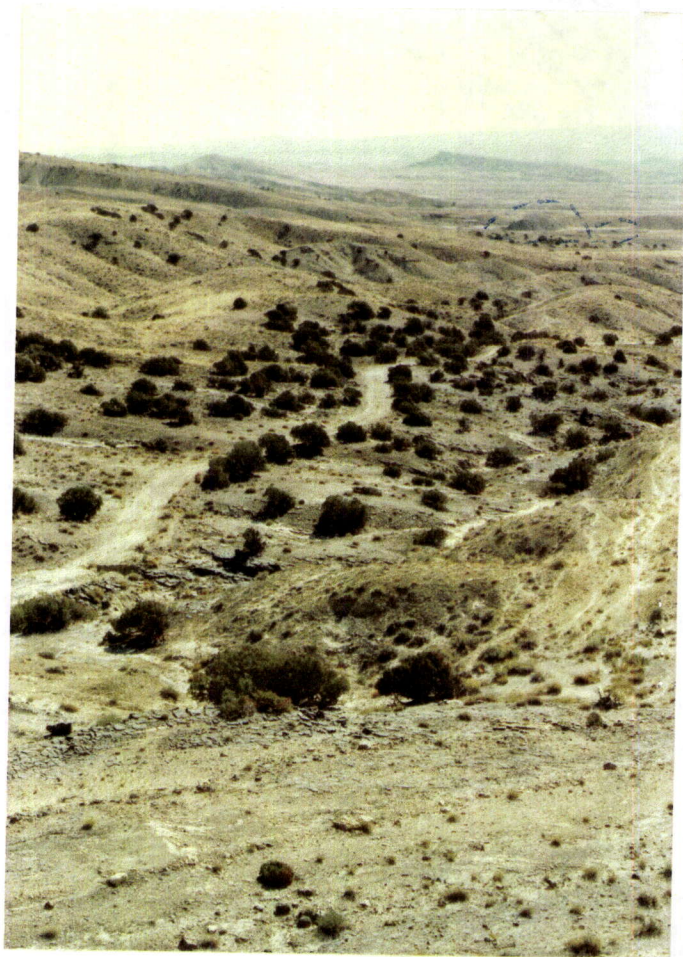
S/047/036 ~~CAMERON #1~~
-NEW PIT PROPOSAL
NATIVE ASPHALT Co.
10/3/91

-VIEW S-SE FROM PROPOSED
SITE, ROAD SOUTH TO CAMERON #1

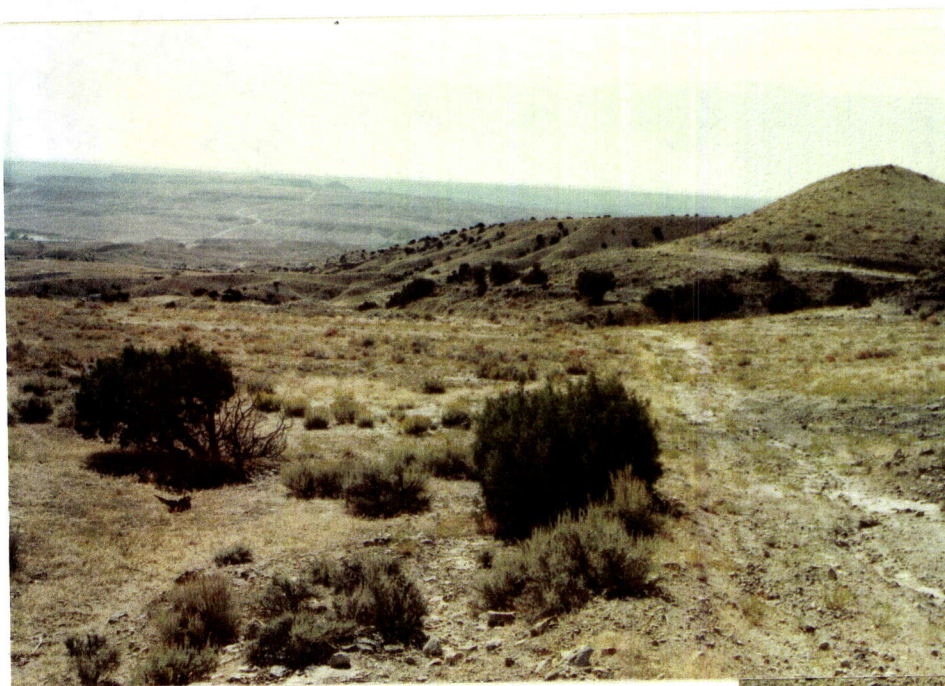
S/047/036 NATIVE ASPHALT Co. 10/3/91
LOOKING NSW

-PROPOSED LOCATION FOR NEW PIT
